**Fire resistance test in
accordance with
European Standard EN
1366-3: 2004 on two Hilti
penetration sealing
systems in a 150mm-
thick reinforced
concrete floor.**

Prepared for:
Hilti Entwicklungsgesellschaft
mbH
Hiltistr. 6
86916 Kaufering
Germany

26th July 2005

Test report number 220849A

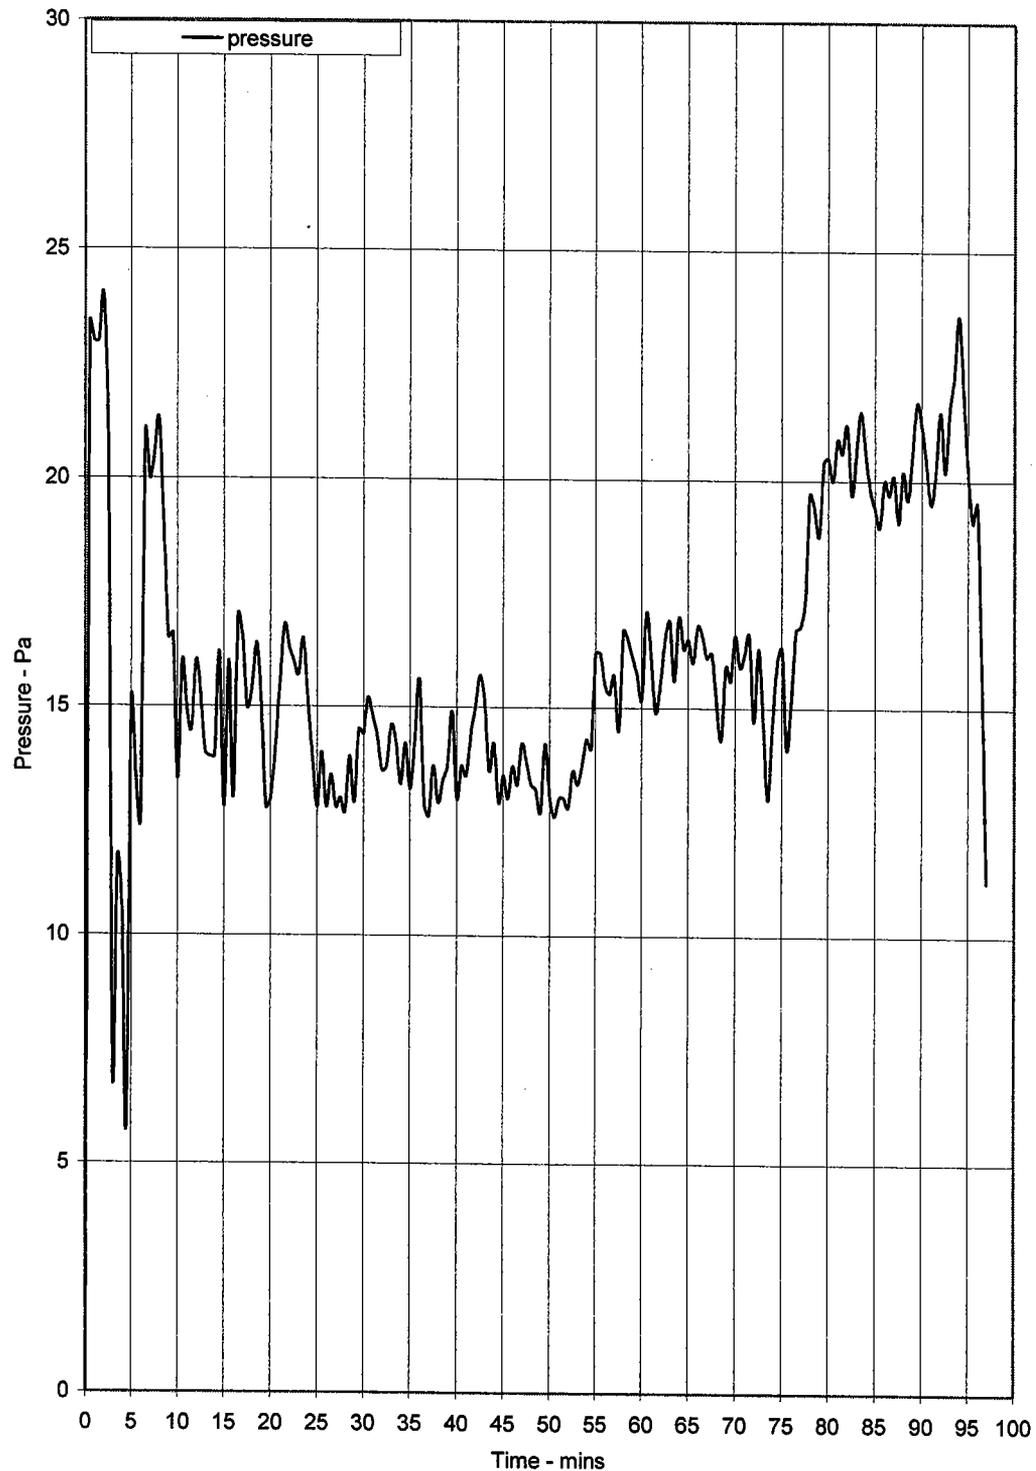
Graph 2 Furnace pressure recorded throughout the test at approximately 750mm below the seals. The increase in furnace pressure after 75 minutes is due to failure of both seal A and seal B affecting furnace control.
